FAXE H2OBLOCK/ PROsystem Report

KRONBORG CASTLE, WINE CELLAR

Helsingør, Denmark

HORNBÆK, 23.05.2016.

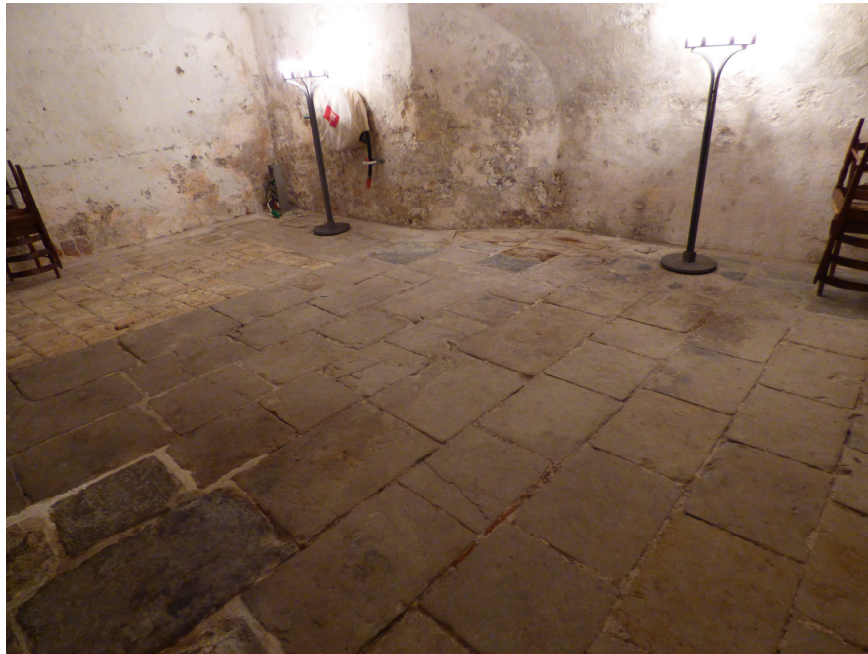
Capillary rising damp is characteristic of old buildings, built at a time when builders were unaware of waterproof materials such as bitumen and the like, which are now used for waterproofing. Moreover, old buildings are often built without foundations, directly on the ground.

Since the basic construction materials (brick, stone, mortar, concrete...) are to a greater or lesser extent porous, through them, that is through micro capillaries existing in their structure, damp gradually moves upward from the soil.

The "culprit" for this is the surface tension of water, which occurs due to the polarization of water molecules, and its direct consequence is capillarity. Due to capillary action, water "climbs" up the wall, and while moving, creates an additional electromagnetic field in the wall, which enhances the capillary effect.

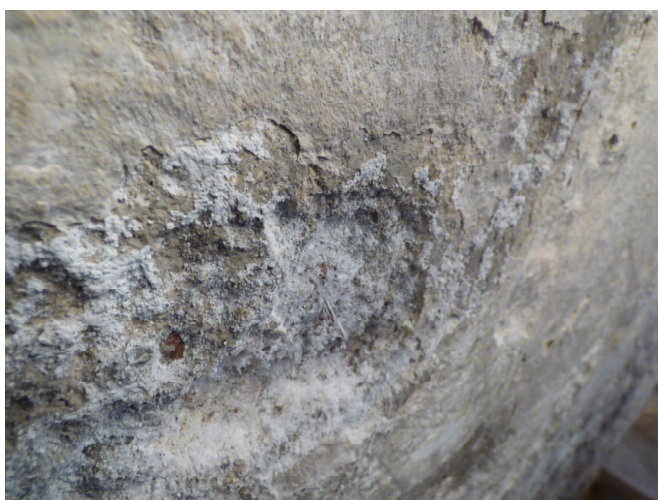
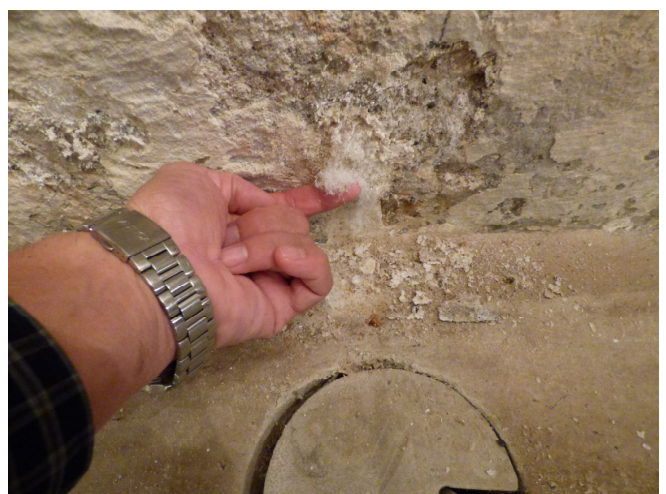
First results of dehidration were noticed already after 24 hours: unpleasant smell became much weaker, "salt beard" appeared on the walls, damaged materials (paint and plaster) began to flake and fall off.

As a result of the dehydration process, materials changed colour (become brighter) and became smoother to the touch.

During the dehydration process, the surface parts of the walls are the first to dry up. Thus, the damaged materials (paint and plaster) increasingly flake and fall off. It is (together with salts appearing in the surface of walls) one of the indicators of the changes that occur due to building dehydration.

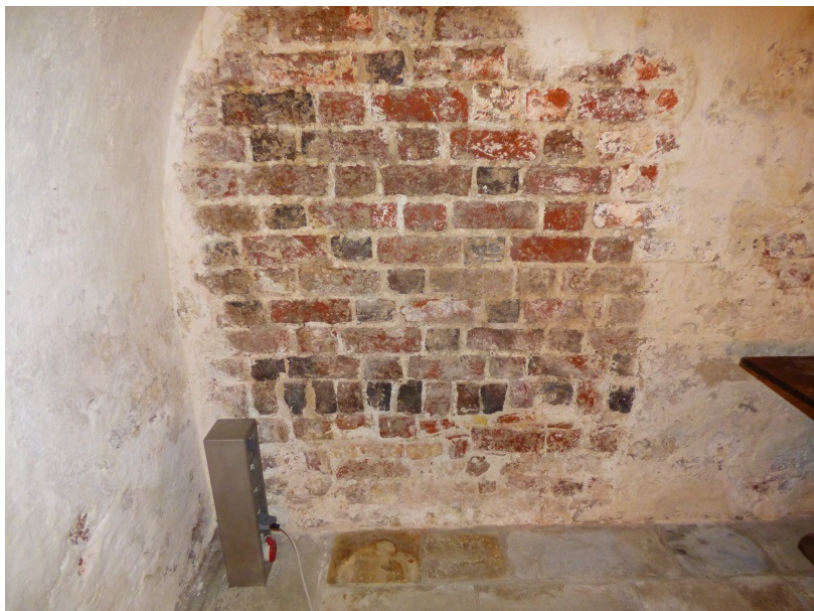
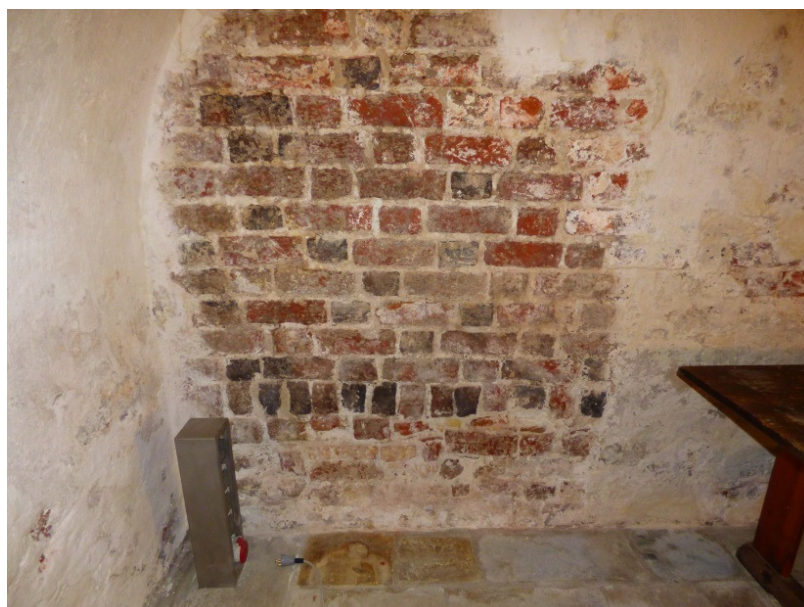
09.10.2014.

10.10.2014.
